RESEARCH MEMORANDUM

ADHESIVE AND PROTECTIVE CHARACTERISTICS OF CERAMIC COATING A-417

AND ITS EFFECT ON ENGINE LIFE OF FORGED REFRACTALOY-26

(AMS 5760) AND CAST STELLITE 21 (AMS 5385)

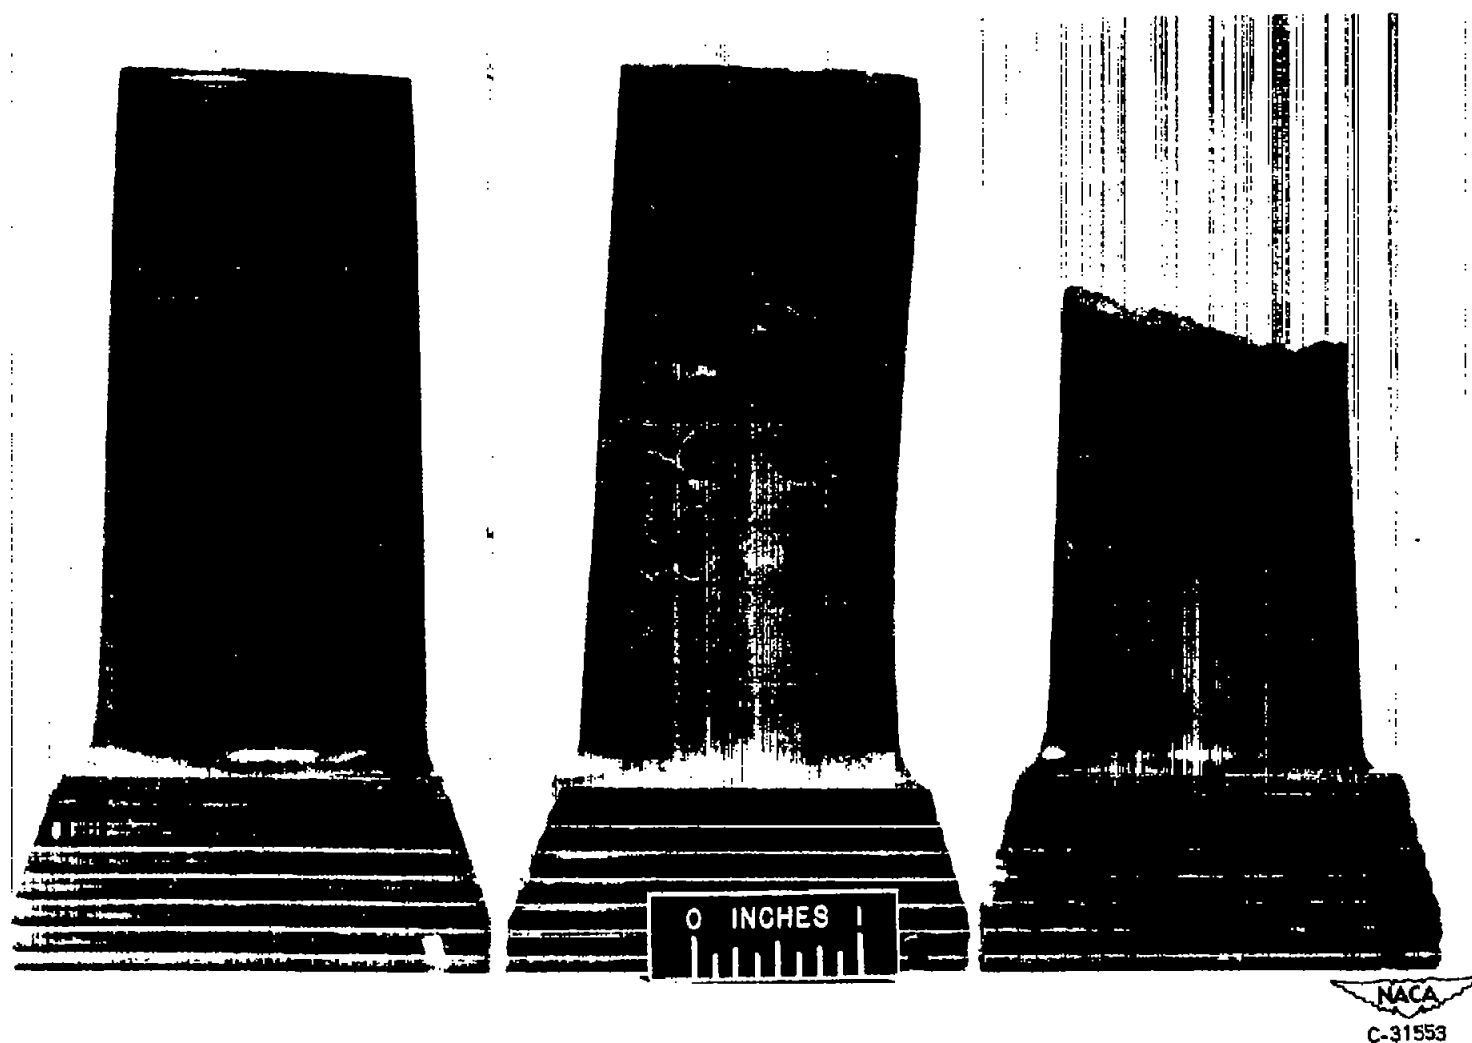
Figure 1. - Comparison of ceramic coated blades.

Appearance of blades. - Appearances of typical coated blades before and after operation are shown in figure 1. The blade in figure 1(a) is representative of as-coated blades. The coating is continuous over the airfoil surface and has a characteristic chromic oxide green color with a vitreous sheen. During operation, the sheen is removed and the color is lightened by the action of the hot gases. The blade of figure 1(b), Stellite 21, and the blade of figure 1(c), Refractaloy 26, are typical blade failures. Stress-rupture cracking of the Stellite 21 blades was not localized to the critical stress and temperature zone (2 in. above the root flat form) but became general over a wide area, giving an "orange peel" effect. Numerous grain boundaries were opened with a consequent shifting of some grains. This mass movement of metal broke the continuity of the coating, as would be expected, but the ceramic-to-metal bond remained intact. The Refractaloy 26 blade failed completely by stress rupture. The spalling of the ceramic coat noted in the center and right-hand blades was caused by fragments of prior failures impinging

on these blades. Macroscopic examination of the coated blades showed that the damage to the ceramic coating by impinging fragments was slight.

(a) As coated; unoperated.

(b) Coated Stellite 21; failed by cracking after 99.7 hours.

(c) Coated Refractaloy 25; failed by rupturing after 99.7 hours.

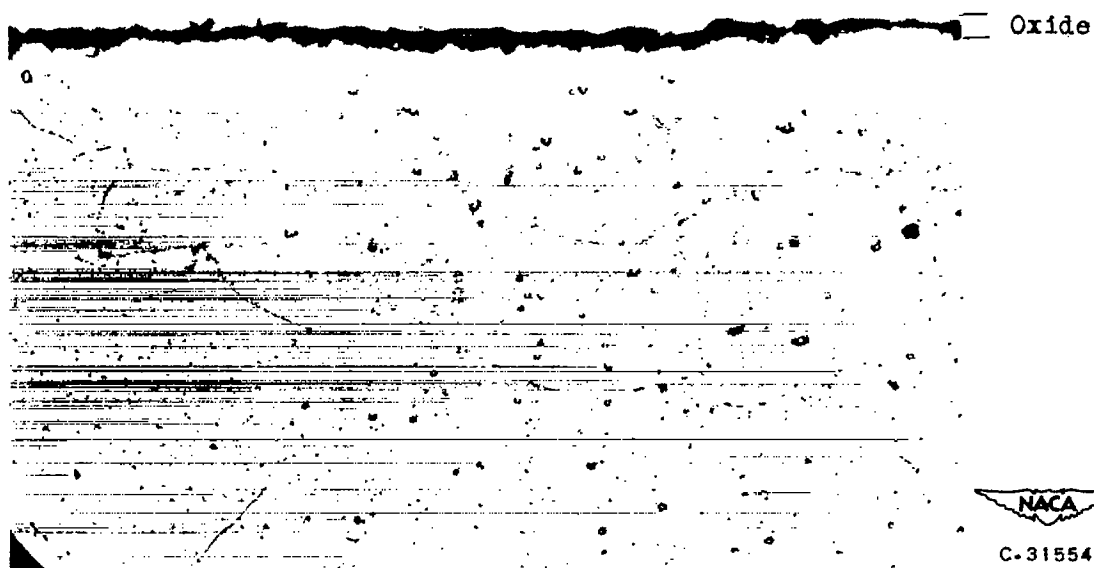
Figure 3. - Oxidation of Refractaloy 26 during heat treatment. Electrolytically etch in 50-percent hydrochloric acid. X250.

Examination of uncoated blades. - A typical oxide coating produced by solution treating and aging Refractaloy 26 is shown in the photomicrograph of figure 3. The oxide layer was approximately 0.00025 inch thick, and penetration of the grain boundaries of the recrystallized zone was observed although it is not apparent in the photomicrograph. Excessive grain-boundary corrosion of uncoated Refractaloy 26 blades operated for 106 and 143 hours is shown in figure 4. Severe corrosion of this type would be expected to lead to short operational life. However, as has been noted, failure times of coated and uncoated blades are practically the same.

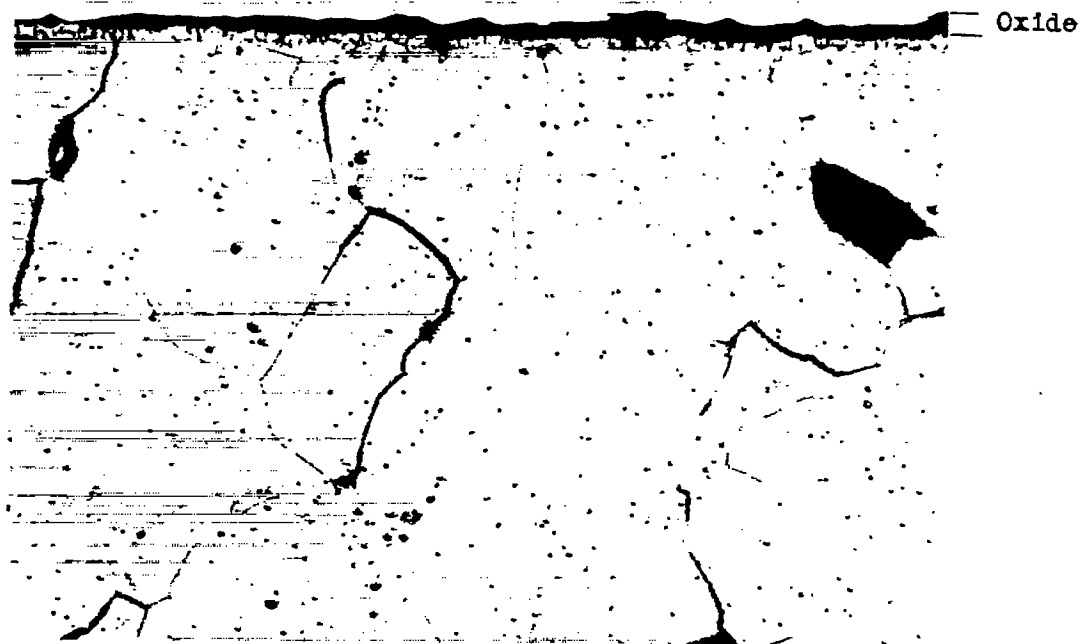
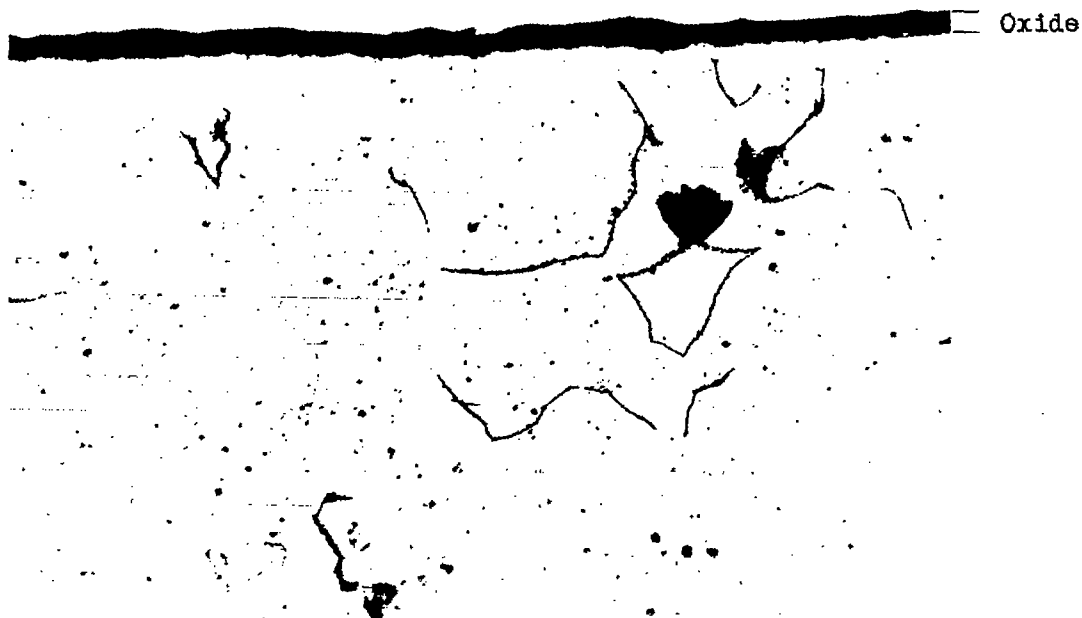
Figure 4. - Extensive grain boundary corrosion of uncoated Refractaloy 26 operated in a turbojet engine.

(a) Fired twice; operated 106.4 hours. Electrolytically etched in 50-percent hydrochloric acid. X100.

(b) Same specimen as in figure 4(a) at X250.

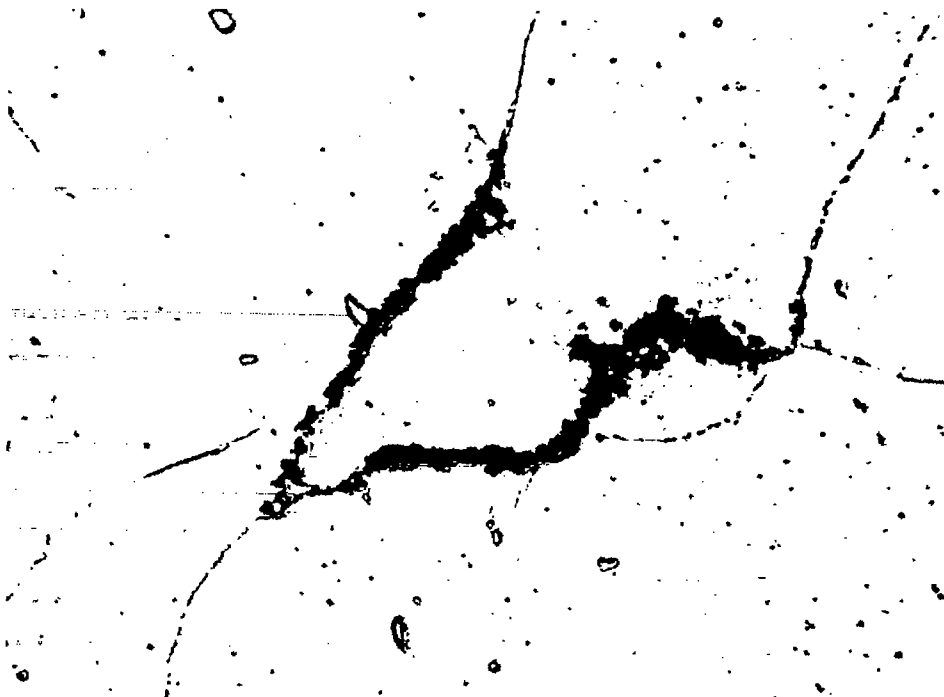
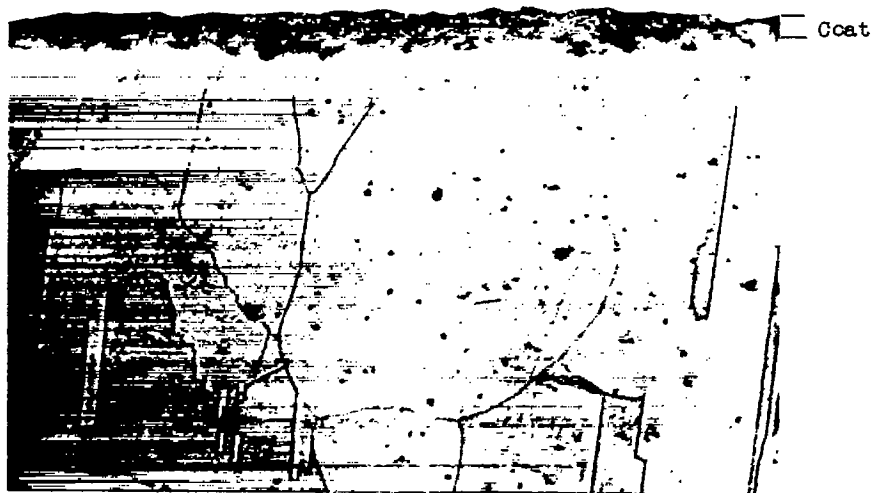
Figure 4. - Concluded. Extensive grain boundary corrosion of uncoated Refractaloy 26 operated in a turbojet engine.

(c) Fired once; operated 142.9 hours. Electrolytically etched in 50 percent hydrochloric acid. X100.

(d) Same specimen as in figure 4(c) at X750.

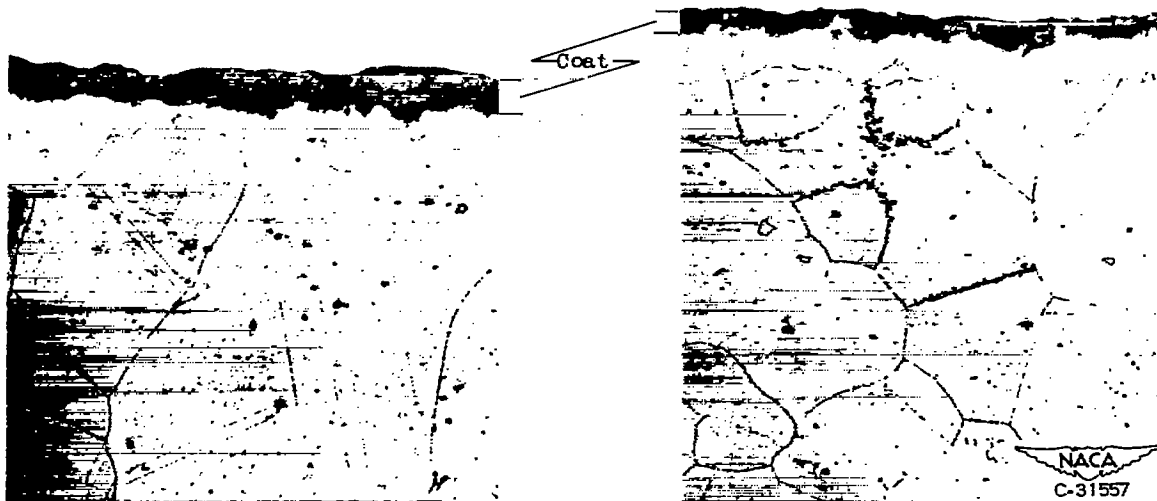
Figure 5. - Ceramic-metal interfaces of coated Refractaloy 26 before and after operation in a turbojet engine. Photographed at X250; reduced 23 percent in reproduction.

Examination of coated blades. - Metallographic examinations of specimens cut from portions of operated blades that did not elongate severely showed that the ceramic coating prevented corrosion and adhered well to the surfaces of the metal (fig. 5). Some of these sections, which were protected from corrosion, were obtained from the immediate vicinity of the fractures, in the hottest, most critically stressed zones of the blades. In other specimens, in areas near the fractures, corrosion was observed, but the fracturing of the ceramic that permitted this corrosion almost certainly occurred after the blade alloy entered third-stage creep.

(a) Fired once; unoperated. Electrolytically etched in 50-percent hydrochloric acid.

(b) Fired once; operated 99.2 hours. Electrolytically etched in 50 percent hydrochloric acid.

(c) Fired twice; operated 149.5 hours. Extensive precipitation in grain boundaries. Electrolytically etched in 50-percent hydrochloric acid.

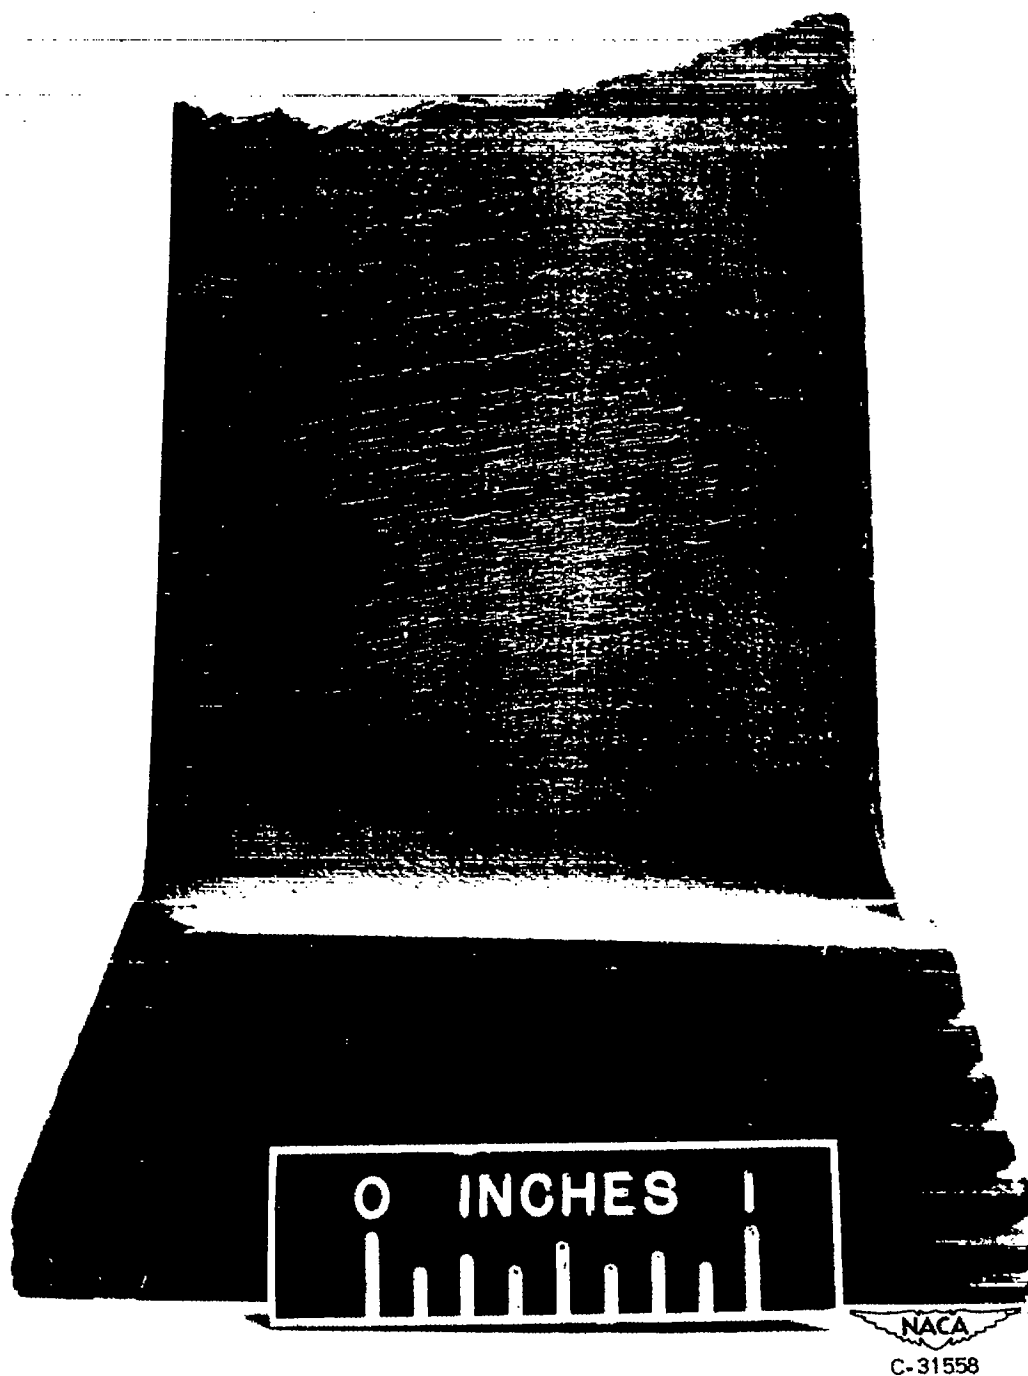
Three of the four blades which had a coat thickness of 1.0 to 2.0 mils developed striations on the concave face during operation (see fig. 6). The striae probably formed in these thick coatings during cooling at shut downs of the engine, which produced an elastic recovery of the base metal.

The ceramic is believed to have flowed plastically as the metal elongated both plastically and elastically during heating. On cooling, the metal recovers by a greater amount than the ceramic. To relieve the compressive stresses, ridges are built up on the outer surface by plastic movement of the coating. This analysis is substantiated by an examination of a cross section of the striae. Photomicrographs of this section (fig. 7) show a ridge and valley on the coat surface, but no visible change occurs to the ceramic-metal interface.

Figure 6. - Striations present in thick coating (1.0 to 2.0 mil) on Refractaloy 26 after 153.6 hours of engine operation.
